NASA TN D-2040

A STUDY OF SEVERAL
OXIDATION-RESISTANT COATINGS
ON Mo-0.5Ti ALLOY SHEET AT 2,500° F

*by Donald R. Rummeler, Bland A. Stein,
and Richard A. Pride*

*Langley Research Center
Langley Station, Hampton, Va.*

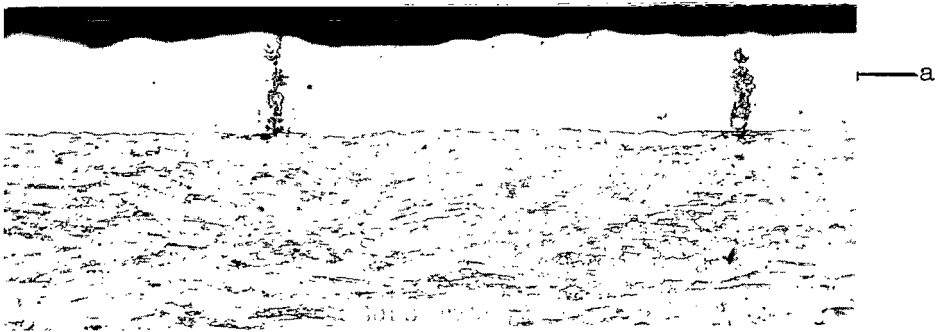
(a) As-coated appearance. X2.

(b) Cross section, bright field illumination. X500.

Figure 5.- As-coated coating B broken-edge oxidation specimen.

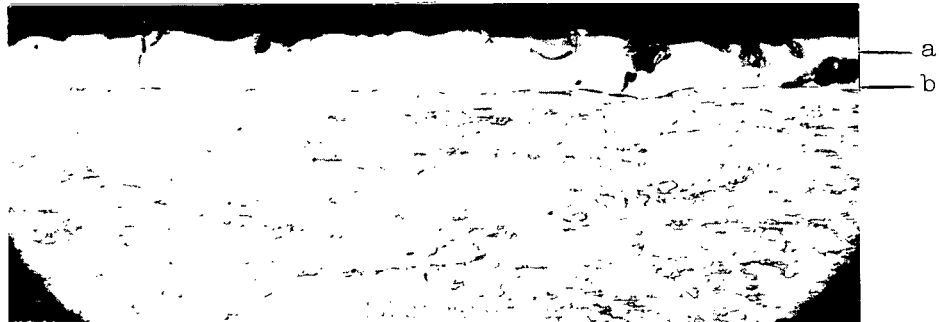
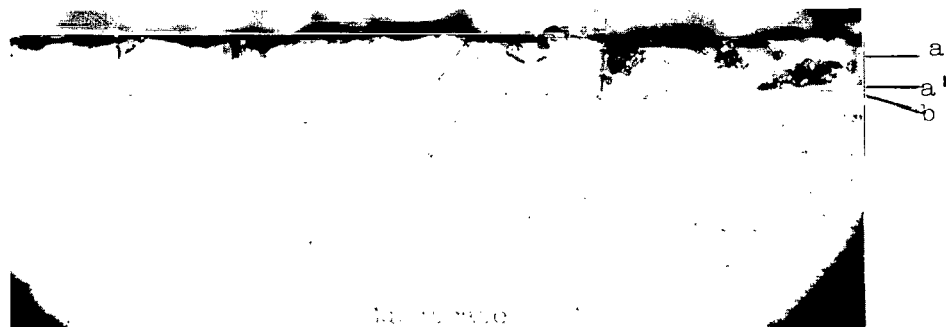
(a) As-coated appearance. X2.

(b) Cross section, bright field illumination. X500.

(c) Cross section, polarized light. X500.

Figure 6.- As-coated coating C broken-edge oxidation specimen.

Coating C: The typical as-coated appearance of coating C (fig. 6(a)), although a highly modified disilicide coating, was characteristically dull gray with a matte texture. Some unevenness of color was noted near the edges but none of the specimens had the mottled appearance of other modified coatings. When examined under bright light, a cross-sectioned specimen (fig. 6(b)) appeared to contain only two phases (a and b). However, when examined under polarized light (fig. 6(c)), the outer phase (a) contained two distinct grain structures (a and a'). Although both are columnar in form, the grain structure on the outer surface (a) consisted of larger grains which were less severely oriented than the inner grain structure (a'). Although it is not clearly apparent in the photomicrograph, the appearance of these two grain structures under polarized light differs considerably from that of the other coatings. In all the other coatings, the phase which was optically active under polarized light (assumed to be MoSi_2) appeared to be composed of varying shades of bluish gray. In coating C this phase was made up of various shades of pink and light gray. This coloring may be due to the $\text{Mo}(\text{Al},\text{Si})_2$ which was identified on the surface of the coating by X-ray diffraction. Although different in appearance, the two grain structures (a and a') exhibited the same Knoop hardness (ref. 6). There was also a thin phase (b) next to the molybdenum substrate which was not active under polarized light and revealed no grain structure with the etchant used. Coating C was the thinnest and most nonuniform of the coatings investigated.

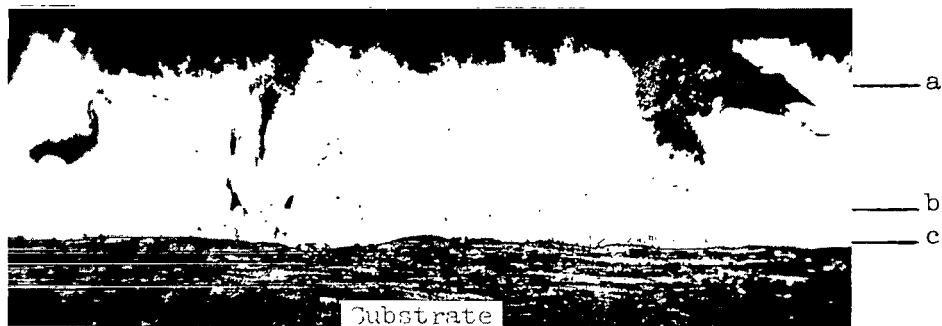
(a) As-coated appearance. X2.

(b) Cross section, bright field illumination. X500.

(c) Cross section, polarized light. X500.

Figure 8.- As-coated coating E broken-edge oxidation specimen. L-63-479⁴

Coating E: Coating E was mottled gray in color and exhibited the roughest surface texture of the coatings supplied (fig. 8(a)). All the broken-edge and sheared-edge specimens which were provided to the supplier for coating applications received additional edge treatment. The edges and corners were rounded abrasively and, as a result, oxidation data presented for the coated broken-edge and sheared-edge specimens are of questionable value for comparing the effects of the different edge conditions. When this coating was cross sectioned and examined under bright light (fig. 8(b)), it was found to contain three distinct phases. The dark outer layer (a) appeared to be dense and showed no grain structure. When examined under polarized light (fig. 8(c)), it was apparent that the outer phase (a) was not just a porous form of the MoSi_2 . The second phase (b) exhibited the columnar, optically active, structure of MoSi_2 when deposited by pack cementation.

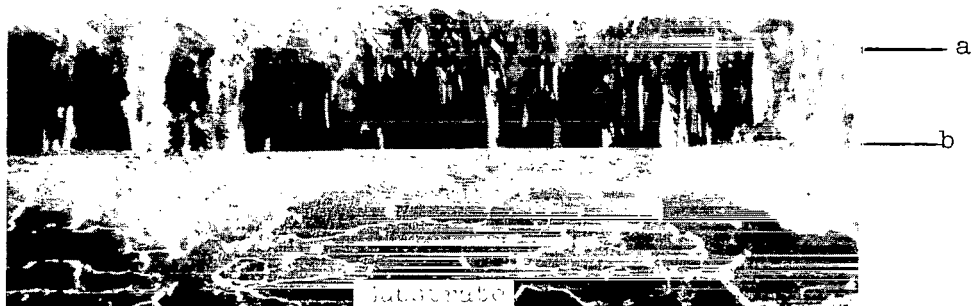
(a) As-coated appearance. X2.

(b) Cross section, bright field illumination. X500.

(c) Cross section, polarized light. X500.

Figure 9.- As-coated coating F sheared-edge oxidation specimen. L-63-4795

Coating F: As was noted for coating E, coating F broken-edge and sheared-edge specimens were given additional edge treatment prior to coating by the coating supplier. The coating surface was mottled dull gray with a matte texture (fig. 9(a)). Coating F under bright light and in cross section (fig. 9(b)) was uniform in thickness. The etchant used revealed a two-phase system similar to the other two-phase coatings. Under polarized light (fig. 9(c)), the optically active MoSi_2 made up the major portion of the coating (a). A thin phase (b) which is assumed to be Mo_5Si_3 separated the MoSi_2 from the substrate. This thin phase, as in the other coatings, showed no grain structure.

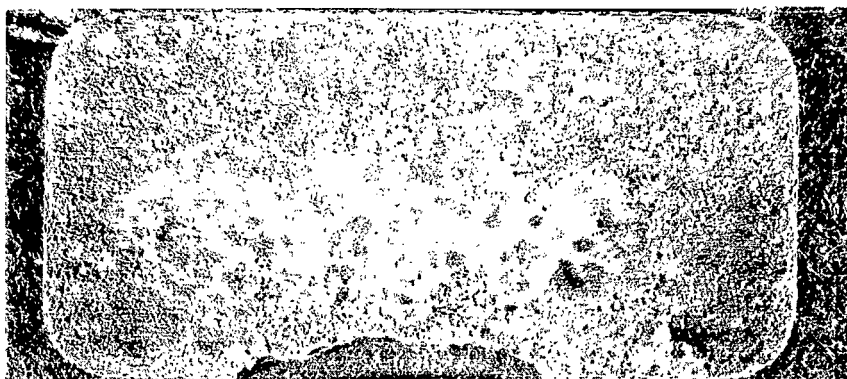
Figure 29.- Coating E tumbled-edge oxidation specimen after forty-four 0.1-hour cycles at 2,500° F in air.

The cyclic tests provided a good opportunity to observe the initiation of failure, and as previously mentioned, visual examination was an unreliable method of detection. After each cycle the specimens were inspected, and in some cases a weight loss of 3 percent did not produce a visible defect in the coating. When a visible defect was found, the specimen was probed to reveal the full extent of substrate damage. Some typical examples of these initial defect points are presented in figures 26(a), 27(a), and 28(a). Figures 26(b), 27(b), and 28(b) present these same specimens after failure. In figure 28 the final failure appears to be only an extension of the original defect. The continued oxidation of the initial defect to produce a 10-percent weight loss was not the only mode of failure. In most of the cycled specimens, other points of failure on the edges were initiated before a 10-percent weight loss terminated the test (figs. 26 and 27). These additional edge failures indicated that the edges of the cycled specimens were marginally protected by the coating when the specimens were subjected to thermal cycling. When the test was terminated, the full extent of substrate damage was not apparent until after the specimens were probed to remove unsound material. Figures 29, 30, and 31 show typical failed specimens before and after probing.

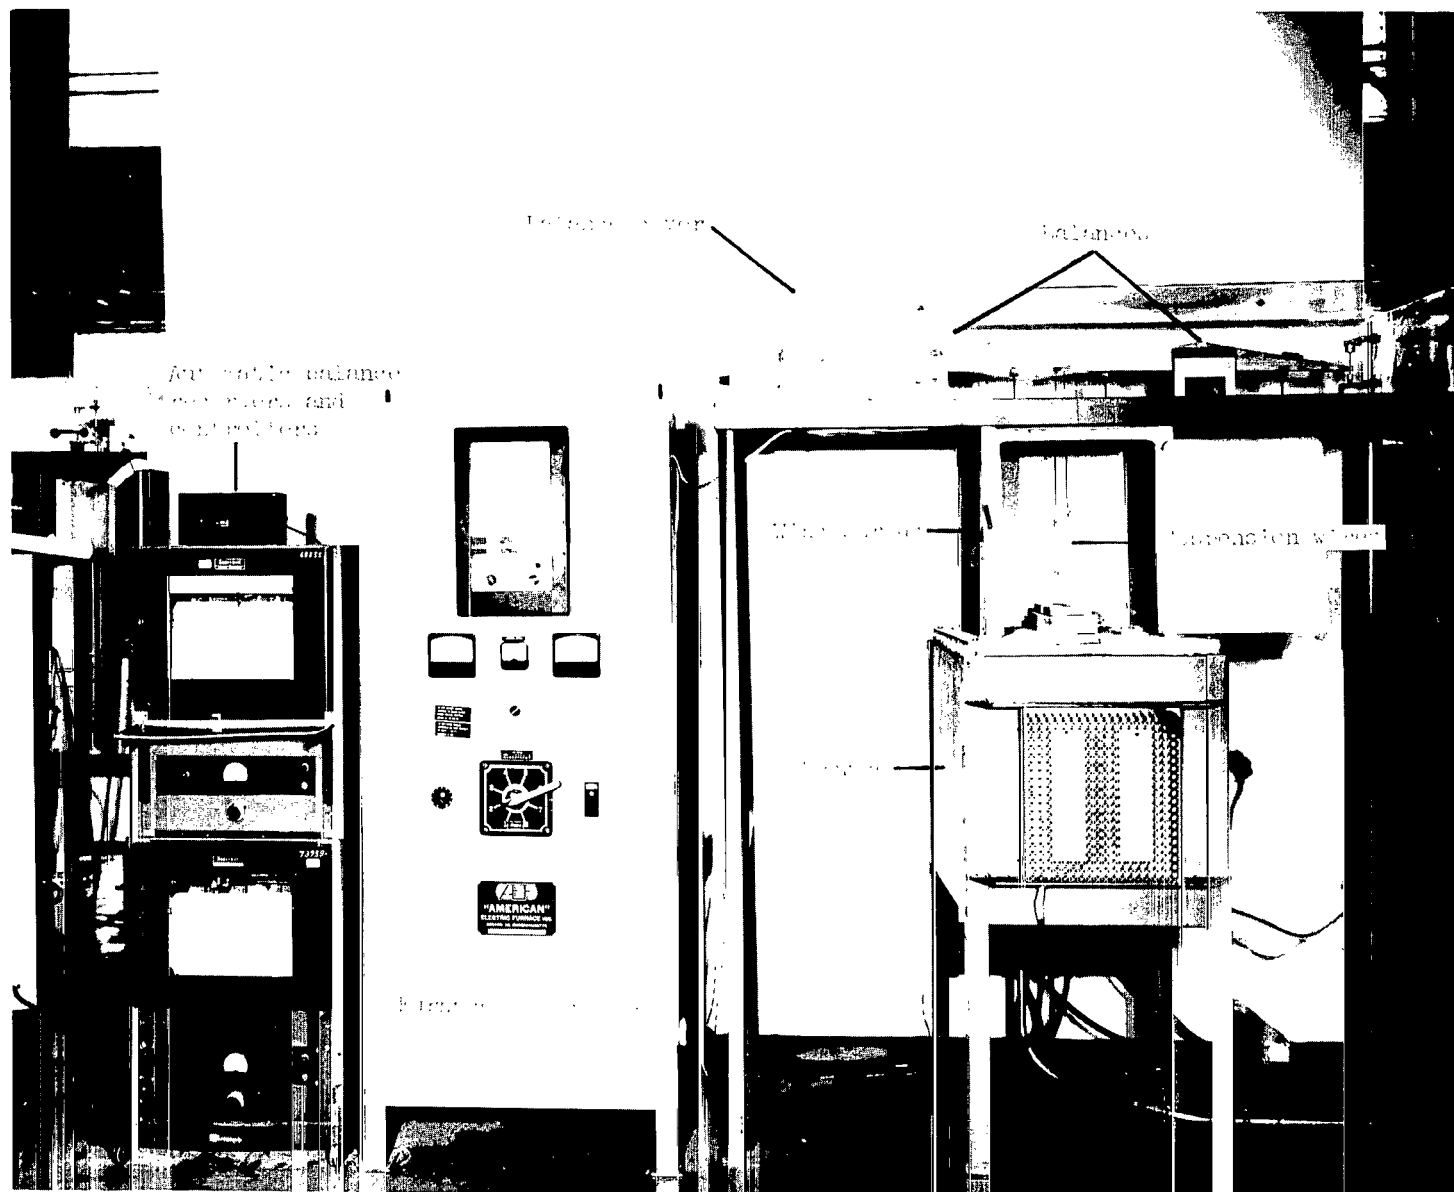
Figure 36.- Vertical tube furnace and associated equipment used for continuous-exposure oxidation tests at 2,500° F in air. L-63-4394.1
